WIND-DAM TECHNICAL REPORT

Product: Wind-dam

Type: 1,6m top mounting

Wind-dam balustrade technical report

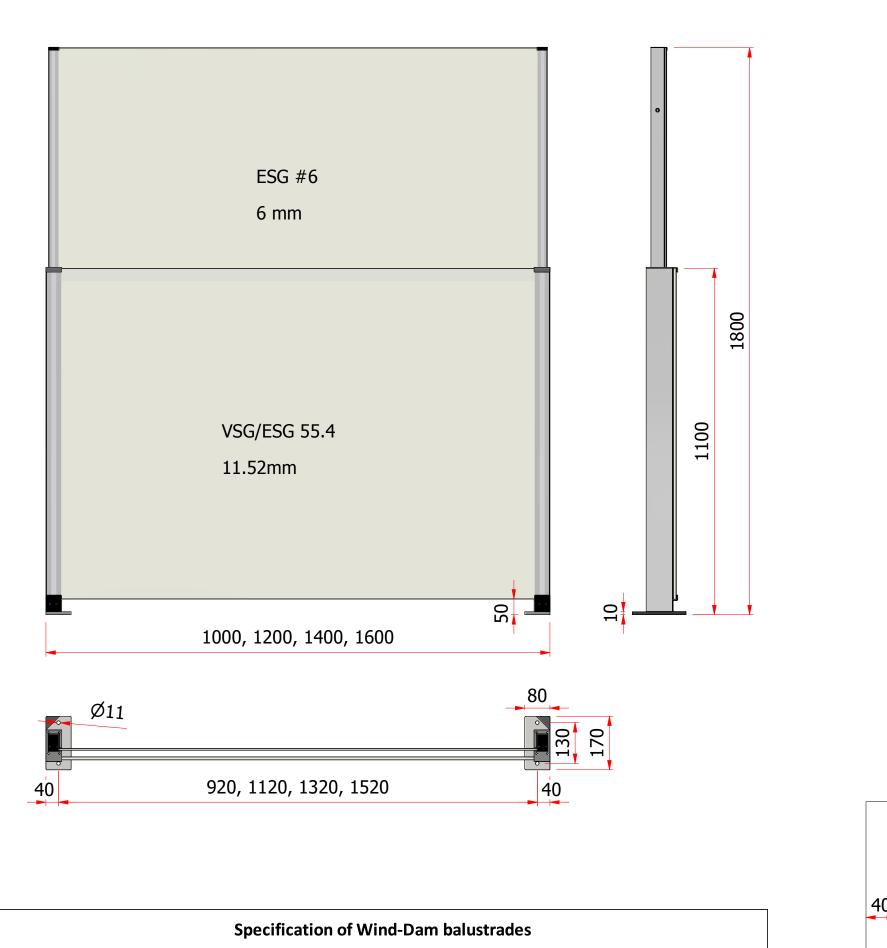
Specification of Wind-Dam balustrades								
Type of installation	Heights	Material	Module length	Strength	Wind resistance	Working temperature		
From the top	1,1 - 1,8 m	Aluminium,	1 m 1,2 m	1 kN/m 1 kN/m	open - 120 km/h	-20*C +60*C		
(M10 8.8)	, ,	stainless steel	1,4 m 1,6 m	1 kN/m 1 kN/m	close - 200 km/h	25 6 155 6

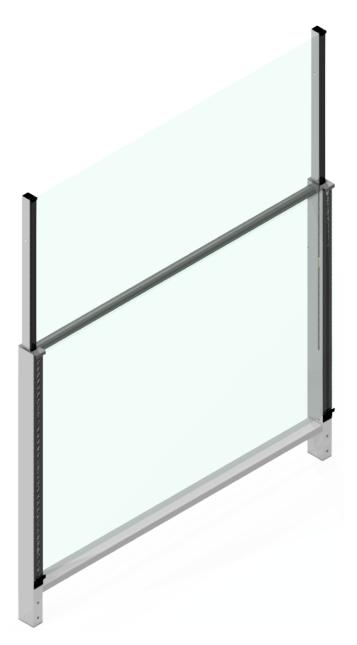
Product: Wind-dam balcony

Type: 1,6m side mount

Wind-Dam 1,6m b	oalcony,	side fixin	g 4 x M1	.0				Observations
Linear load force [kN]	0	1,6	2,4	3,2	4	4,8	0	No any damage during the test. After removing the force, the balustrade returned to its original
Measurement temporary deflection [mm]	0	14	20	24	30	36	0	position, with zero residual deflection.

Balustrade ressisted 3 times test of soft body impact. After each hit, the whole structure was inspected for potential permanent deformation or connections damage. None was noticed.
